Contract #: 04-0120F4Cty: SF/ALA Rte: 80 PM: 13.2/13.9File #: 69.28**WELDING INSPECTION REPORT****Resident Engineer:**Pursell, Gary**Address:** 333 Burma Road**City:** Oakland, CA 94607**Report No:** WIR-008561**Date Inspected:** 17-Aug-2009**Project Name:** SAS Superstructure**OSM Arrival Time:** 1900**Prime Contractor:** American Bridge/Fluor Enterprises, a JV**OSM Departure Time:** 700**Contractor:** Zhenhua Port Machinery Company, Ltd (ZPMC), Changxing Island **Location:** Shanghai, China**CWI Name:** Xu Yumin**CWI Present:** Yes No**Inspected CWI report:** Yes No N/A**Rod Oven in Use:** Yes No N/A**Electrode to specification:** Yes No N/A**Weld Procedures Followed:** Yes No N/A**Qualified Welders:** Yes No N/A**Verified Joint Fit-up:** Yes No N/A**Approved Drawings:** Yes No N/A**Approved WPS:** Yes No N/A**Delayed / Cancelled:** Yes No N/A**Bridge No:** 34-0006**Component:** OBG**Summary of Items Observed:**

OBG SEGMENT-1AA E-1AE-1BE

WELDING INSPECTION REPORT

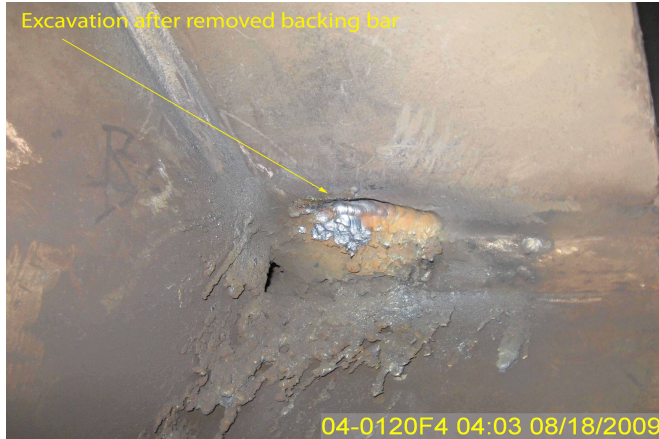
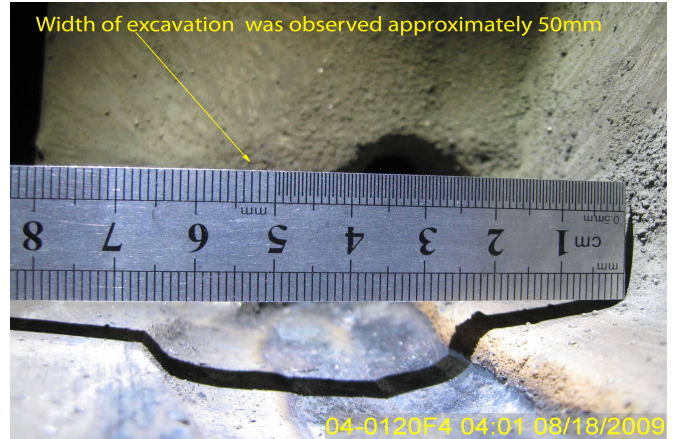
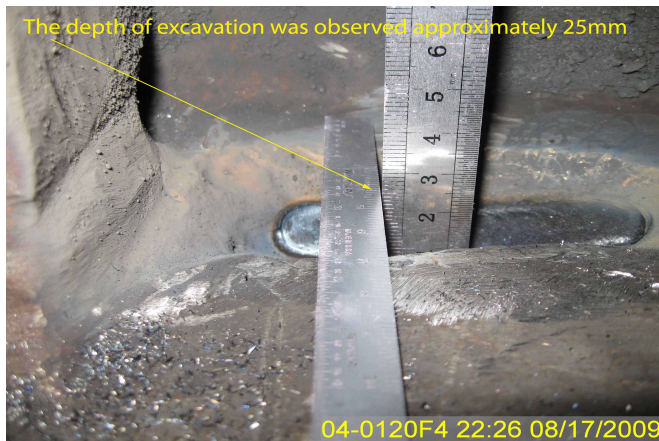
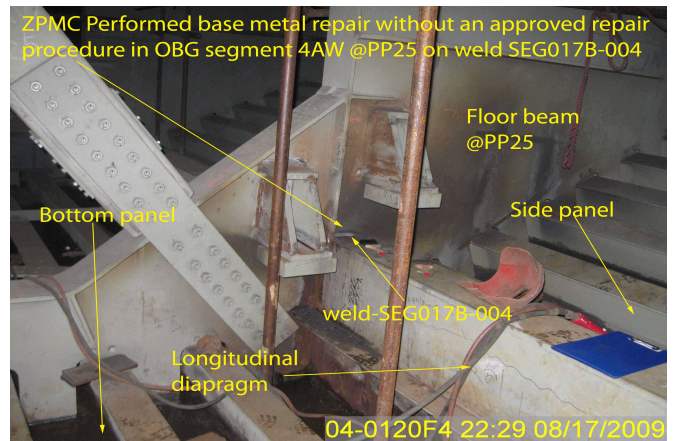
This Caltrans Quality Assurance inspector (QA) observed that the contractor has performing base metal repair on OBG segment 4AW adjacent to the weld SEG017B-004 at the intersection of PP025 and W3. This QA observed that the contractor has gouged all the way through the thickness of the top flange of longitudinal diaphragm (LD5E) and placed a backing bar on the underside of the repair area. The backing was removed after the welder ran several weld passes in the groove. The repair excavation is measures approximately 100x75mm and 25mm deep (flange thickness = 25mm). This base metal repair was performed without the approval of the Engineer. For additional information see attached pictures. Incident report was send to task leader and other supervisor.
